Pregledni znanstveni članek – Review scientific paper

SAFETY PROBLEMS OF SMALL EMBANKMENT DAMS IN THE CZECH REPUBLIC VARNOSTNI PROBLEMI MALIH NASUTIH PREGRAD NA ČEŠKEM

Jaromir Riha^{1,*}

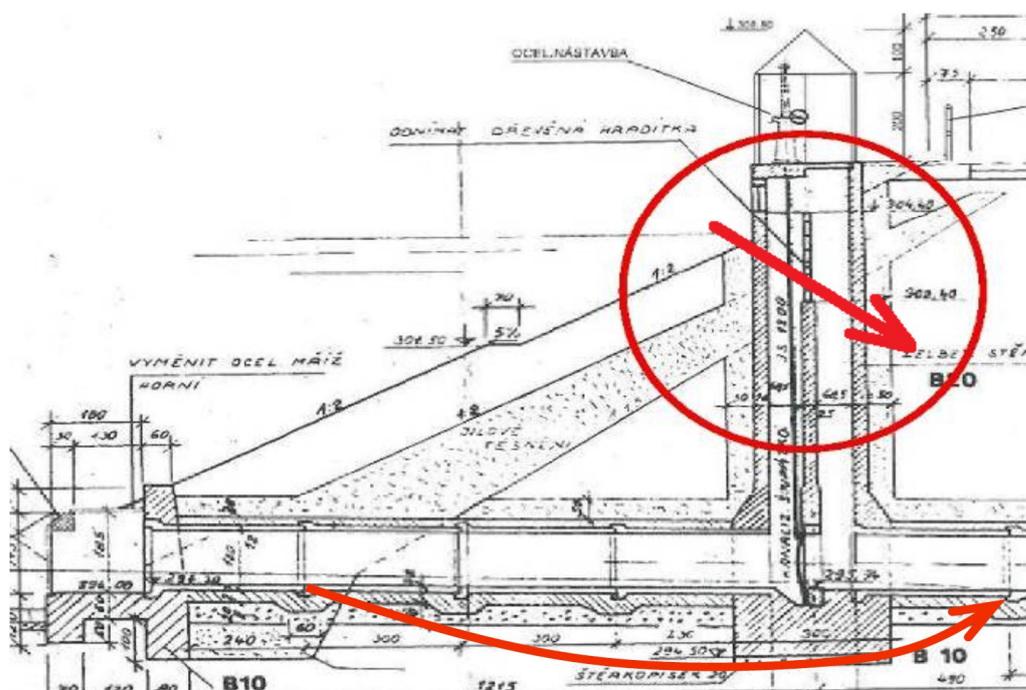
The outflow pipe should be designed to pass the design discharge with the free water surface. When the valve tower is located at the dam body (Figure 2), the inflow pipe functions as a pressure pipe. The submerged inlet is equipped with a screen and is not normally accessible. In the valve tower the water level is usually maintained by a stop log installed inside the shaft. In many cases the stop log wall is equipped with a valve located at the bottom of the tower. The valve enables water level regulation without adjustment to the stop log. The outflow part of the bottom outlet is usually constructed from concrete pipes ending in a stilling basin. To ensure free surface flow within the outflow pipe, the entrance to the pipe should be equipped with a reduction cone and air inlet. Sometimes the inlet is designed as a submerged structure and cannot be operated during a flood. In this case, supplying air is complicated.

Figure 2: Improper conceptual design of a bottom outlet. Concentrated leakage is marked with arrows.

It is common for bottom outlet pipes to be in bad condition. Camera inspections of bottom outlets frequently show cracks in pipes or damaged joints between socket pipes. This is often due to intensive seepage and the flushing out of soil particles from the space behind the pipe (Figures 2, 7). Cracks and shifts in joints result in the seepage of turbid water, which indicates internal erosion of the soil along the bottom outlet. An additional survey via geophysical methods and boreholes usually completes the information about the conditions at the back side of the pipe. The development of a seepage path with concentrated leakage when it has progressed further can lead to subsidence of the dam crest and also to continuation of the breaching process.

Seepage through the dam body is signalled by wetting of the downstream face. In many cases the wetted area is quite large and its elevation is significantly higher than the downstream toe of the dam. This seepage may be caused by many factors, e.g. improper construction materials, insufficient compaction or an incorrect conceptual design of appurtenant structures. Figure 2 shows a case where the regulating tower is constructed as part of the dam body and “intersects” the upstream sealing element. At this dam, intensive seepage was observed approximately 3 m above the downstream toe of the dam.

Seepage into the bottom outlet pipe (Figure 2, 7) can result in shortcutting and further development of the seepage path, an increase in the hydraulic gradient and sometimes in defect propagation leading to dam collapse. This can also occur in the case of seepage along the side wall of spillways where freezing of soil makes it denser and thus more susceptible to the continuation of seepage and internal erosion (Figure 8).

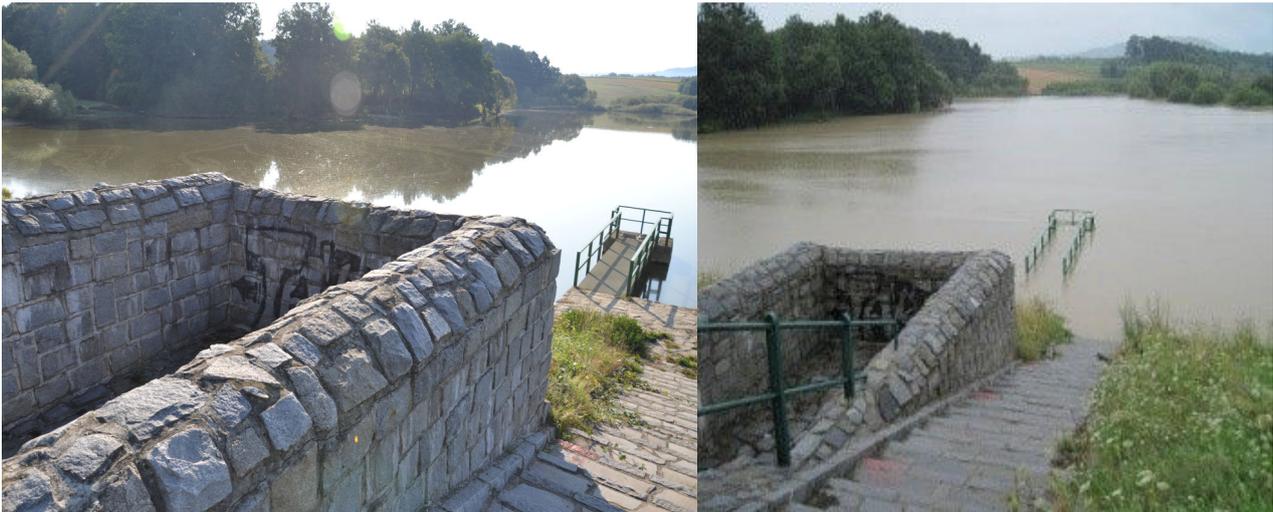
Figure 3: Submerged bottom outlet entrance and its operation during a flood.

The operation of valves and gates during extreme situations is described in the operating rules of the reservoir. In many cases the options for their operation during a flood (e.g. the opening of valves, etc.) are limited due to the fast arrival of the flood wave, which in the case of most small reservoirs occurs within 5 hours. Also, poor dam accessibility and the condition of the appurtenant works can complicate the operation of valves or gates during a flood (Figures 3, 5).

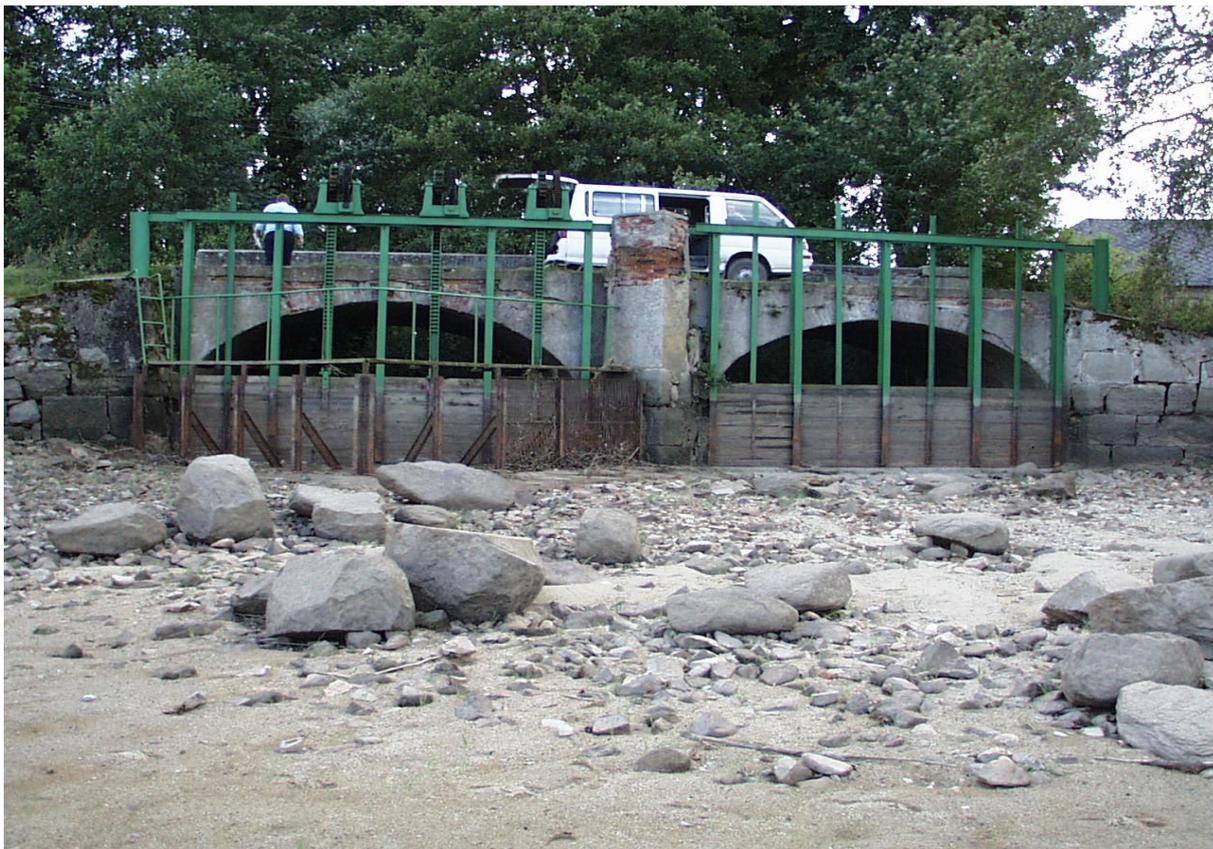
Figure 5: Gated sluice with damaged propulsion equipment.

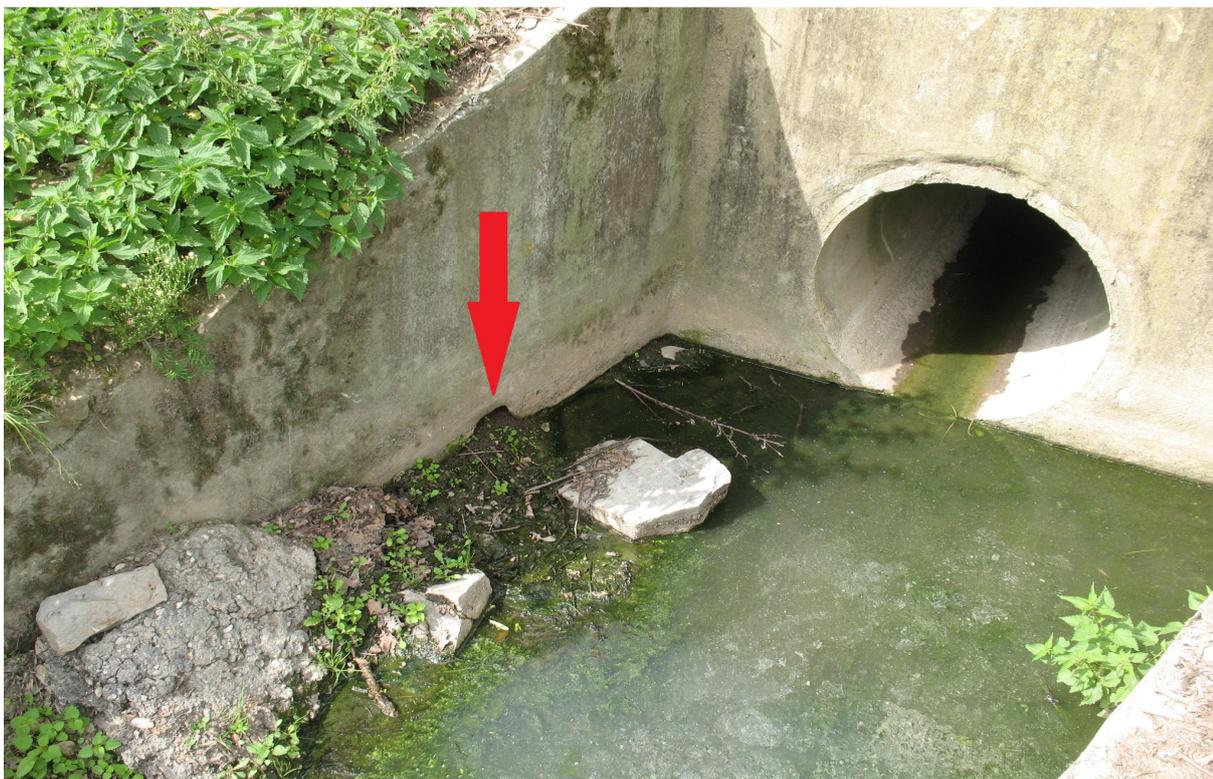
Back flooding of the bottom outlet can usually be expected due to the limited capacity of the downstream channel. It frequently occurs when the downstream end of the bottom outlet is low (Figure 6) and also the end of the spillway chute joins the channel just downstream of the stilling basin of the bottom outlets. A check flood passing through the spillway is usually dominant when compared with bottom outlet flow. When this occurs, backwater propagating upstream to the bottom outlet reduces its capacity. Moreover, in this case the flow regime in the bottom outlet may periodically change from free surface to pressure flow and back again. Such changes cause dynamic loading on the outlet pipe.

Figure 6: Low downstream end of a bottom outlet with submerged drain pipes (arrow).

It often happens that seepage cannot be monitored due to the lack of a toe drain and efficient drainage system. Sometimes the drainage pipes feed into the tailwater below the downstream water level and are subjected to backwater from the stilling basin (Figure 6).

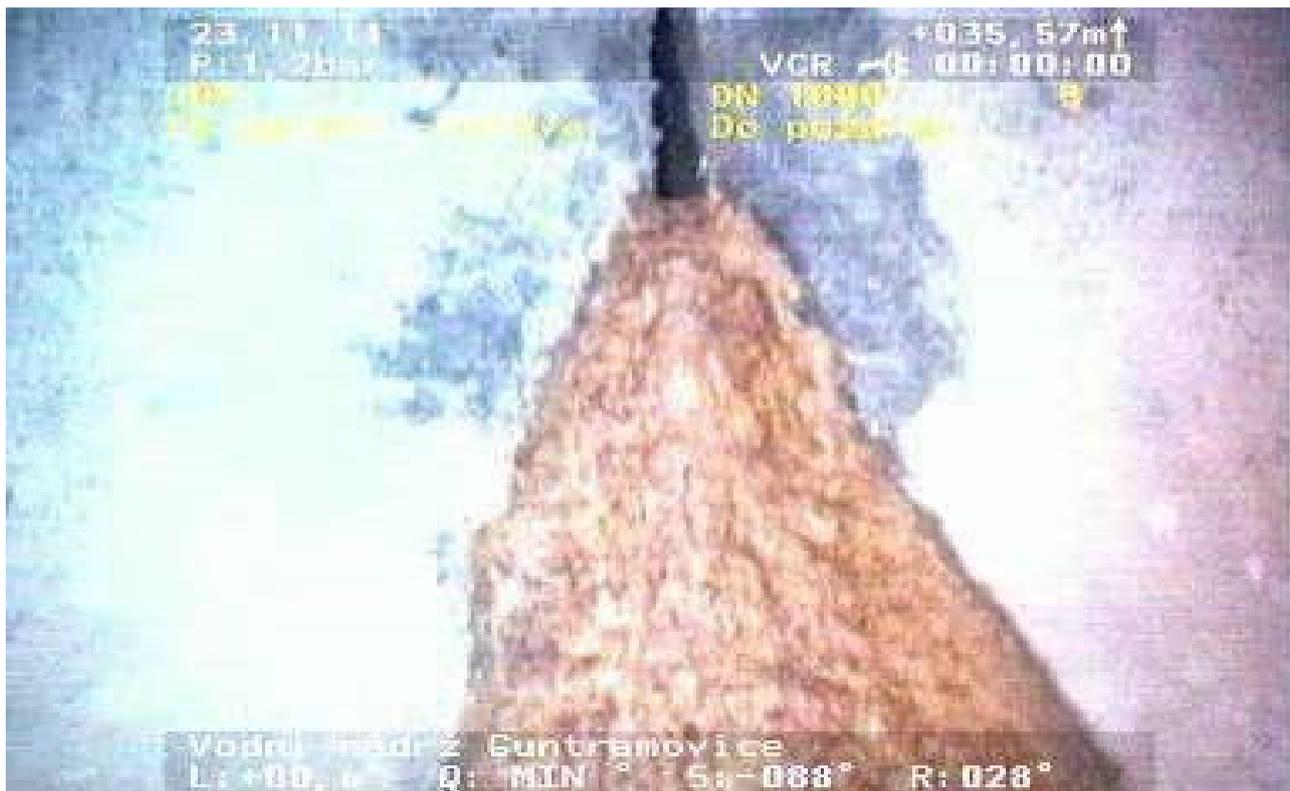
Figure 7: Crack in the bottom outlet pipe with turbid seepage into the pipe.

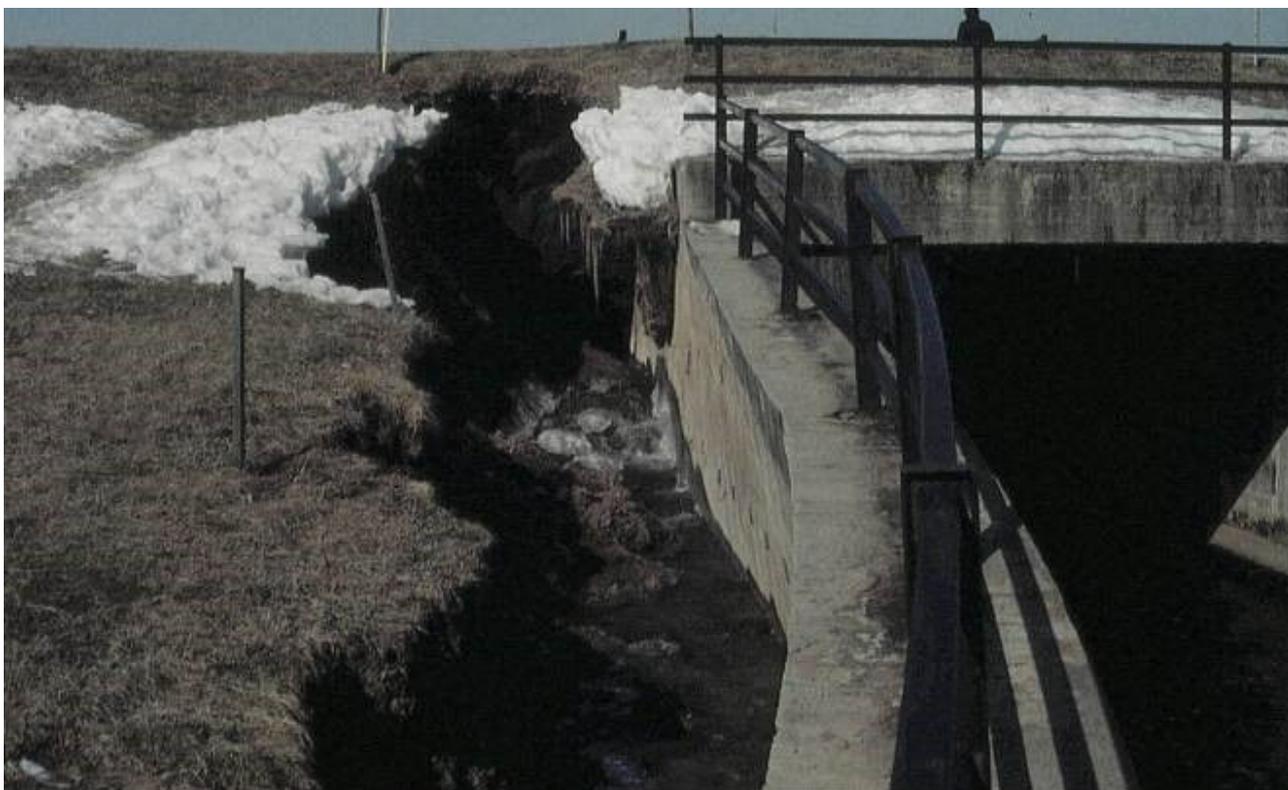
Figure 8: Dam collapse due to internal erosion along the spillway.

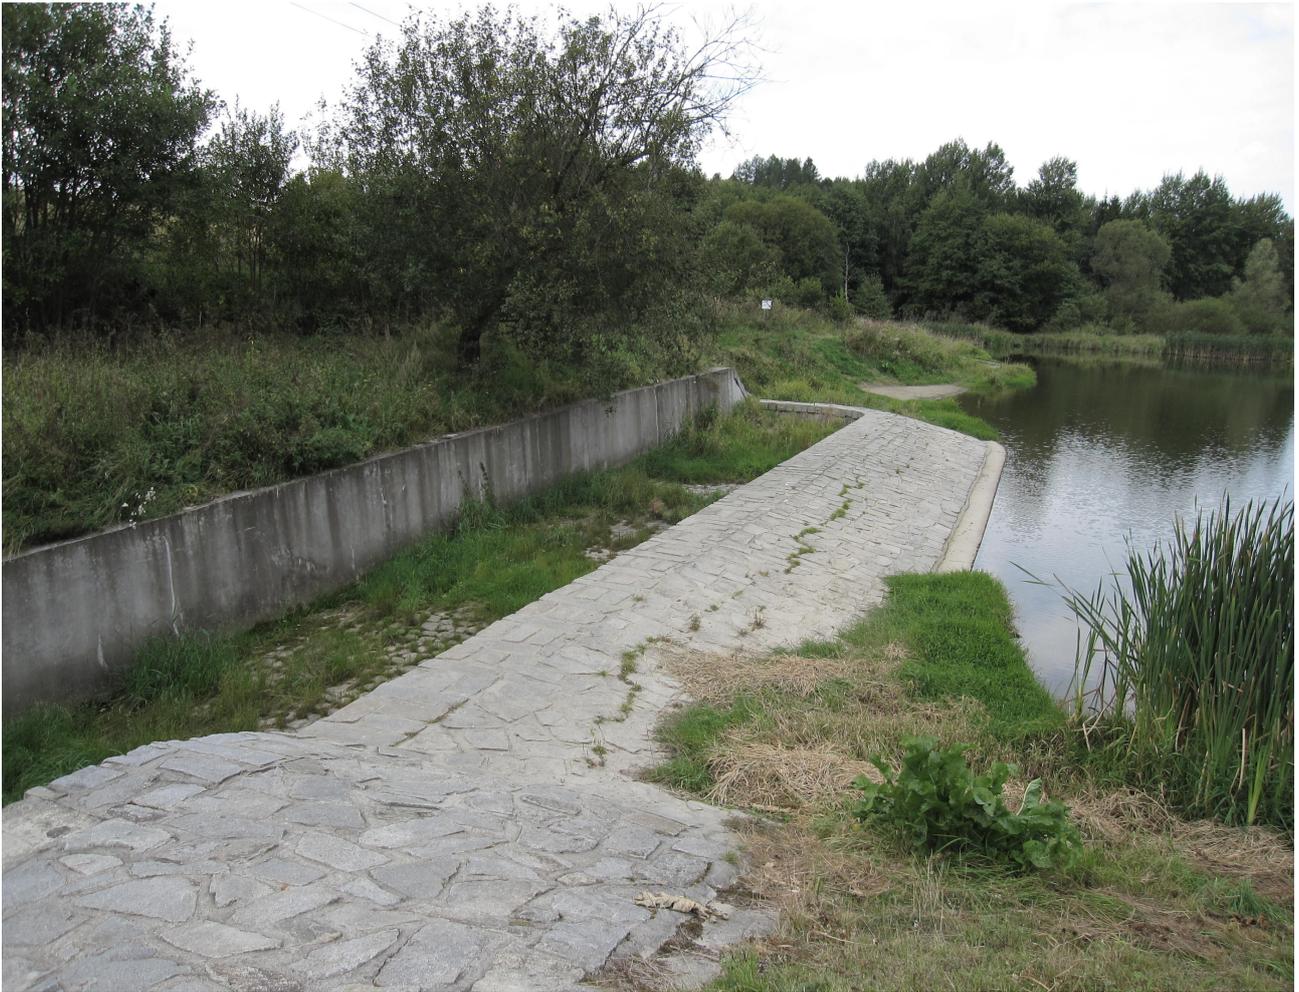
Weir capacity is often limited by a shallow spillway chute below the weir, especially in the case of a very long weir crest (Figure 9). In such conditions back flooding can be expected.

Figure 9: Long, shallow and narrow spillway channel affected by sediment and vegetation.

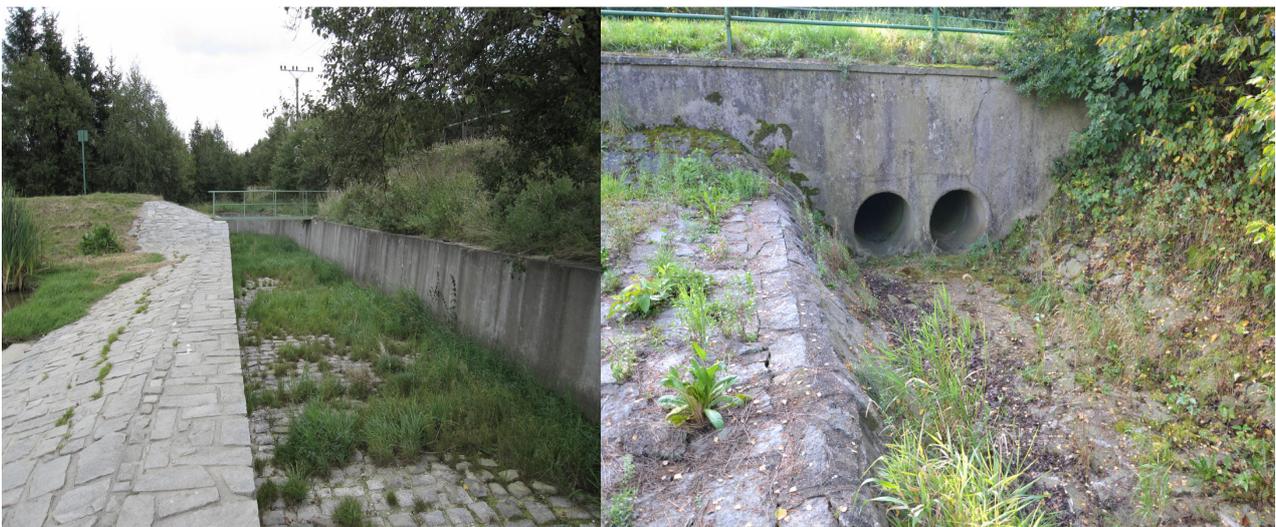
A crucial section for the back flooding of the weir is usually at the intersection of the chute and the dam crest. At this location the flow is often reduced by a narrow bridge profile, culverts (Figure 10), or by an improperly designed footbridge. These structures cause back flooding of the spillway channel and reduce the capacity of the whole spillway.

Figure 10: Crossing of the spillway chute with the dam by a narrow bridge (left) and culvert (right).
