Pregledni znanstveni članek – Review scientific paper

## THE SAVA RIVER CHANNEL CHANGES IN SLOVENIA SPREMEMBE STRUGE REKE SAVE V SLOVENIJI

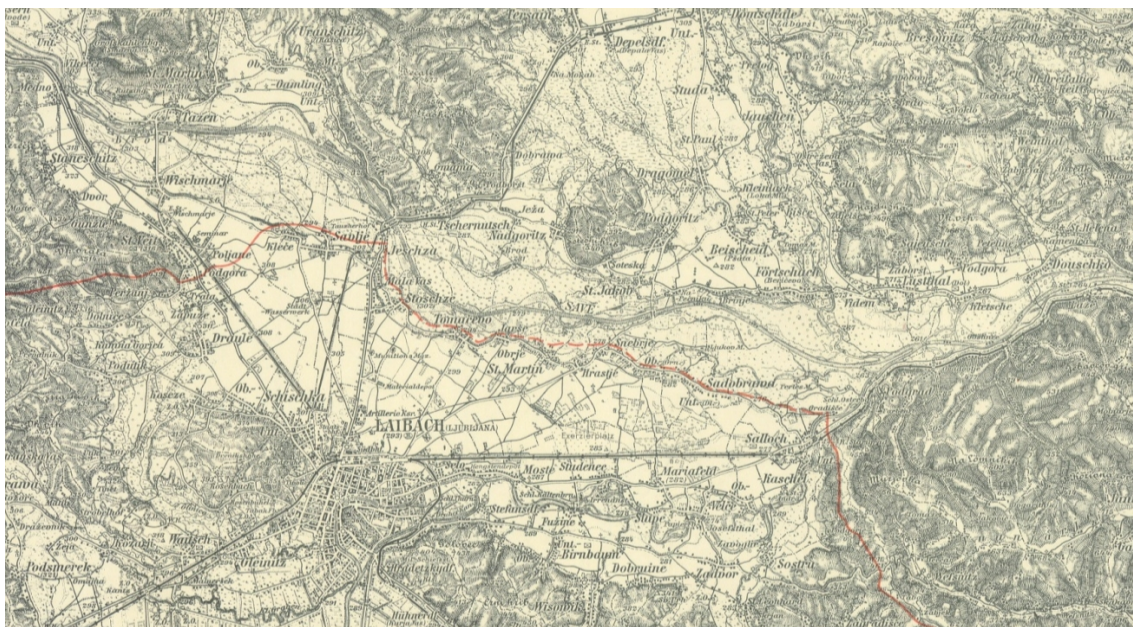
**Figure 4:** The map in the scale 1:75,000 (situation in 1914), showing the same reach as shown in Fig.1 at the beginning of WW I; the red line is the state border during WW II between Italy (in the south) and Third Reich (in the north) (Militärgeographisches Institut, 1941).

**Slika 4:** Zemljevid v merilu 1:75.000 (razmere iz leta 1914), prikazuje odsek kot na sliki 1 na začetku 1. svetovne vojne; rdeča črta prikazuje državno mejo med 2. svetovno vojno med Italijo (na jugu) in Tretjim rajhom (na severu) (Militärgeographisches Institut, 1941).

Before 1780, the first regulation works as a combination of riprap made of manually levelled quarry stone and dry stone wall were done close to Dolsko to protect the river port and the settlement. This can still be partially found in situ. More systematic works started after 1880, namely as protection works on the Sava River right banks between Tacen and Črnuče – the river regulation works stopped with the First World War (WWI) (for situation in 1887 see Fig. 3, and in 1914 see Fig. 4).

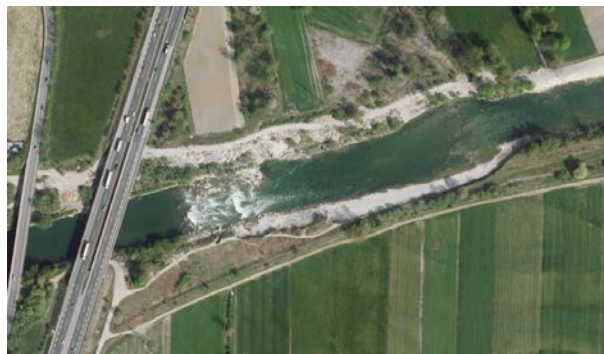
**Figure 6:** The riverbed ramp downstream of the Šentjakob highway Bridge prior to the Sava 2012 Flood (source: Atlas okolja, 2016).

**Slika 6:** Drča dolvodno od avtocestnega mostu v Šentjakobu – pred poplavo 2012 (vir: Atlas okolja, 2016).

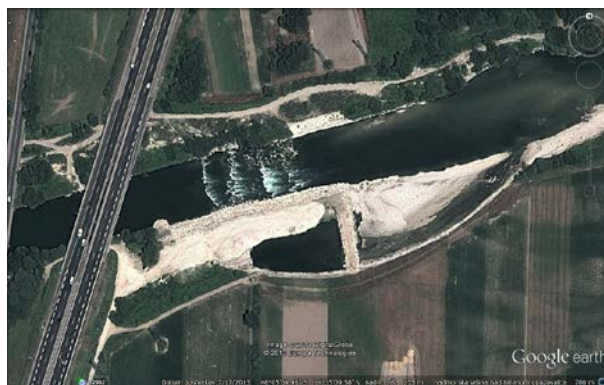
**Figure 7:** The riverbed ramp downstream of the Šentjakob Highway Bridge after the Sava 2012 Flood. The flood caused a local right bank cut downstream of the ramp; the repair works have already been done (source: Google Earth, July 17, 2013).

**Slika 7:** Drča dolvodno od avtocestnega mostu v Šentjakobu – po poplavi 2012. Poplava je dolvodno od drče spodjedla desno brežino reke Save; sanacijski ukrepi so že bili izvedeni (vir: Google Earth, 17. 7. 2013).
